Problem:

Burn Marks

TECH TIPS

Rev. 04/2020 TT002

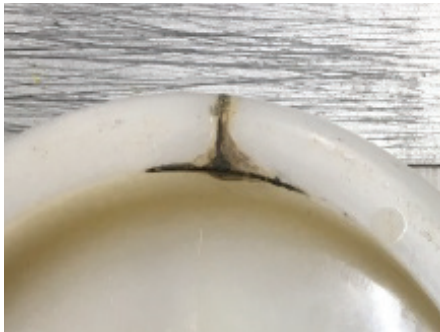
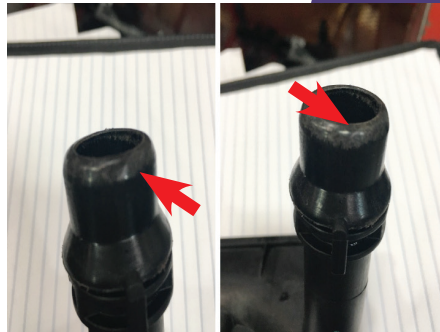
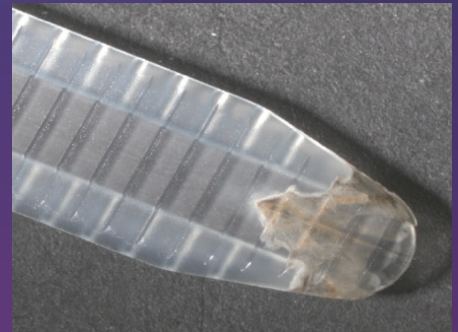
Burn marks are dark brown and black discolorations or charring located on the molded part surface.

Root causes

Several factors can cause burn marks. These factors can be related to the mold, machine, process or material. Some of the more common causes are:

- Inadequate venting
- Excessive temperatures in the barrel, nozzle and hot runner system
- Excessive shear in the nozzle, runner, gate or part
- Excessive moisture and/or air entrapment in the material
- Extended residence time in the barrel
- Material contamination
- Poor part/gate design and location
- Irregular regrind shape/size
- Excessive injection speed

Overheated material is one of the most common causes of burn marks. When nylon overheats, it can degrade, resulting in burned areas in the part.

Follow the temperature guidelines recommended by the material manufacturer.

- Check the melt temperature using a thermocouple to find the actual melt temperature.
- If using a hot runner system, temperatures in the manifold and drops should be equal to the desired melt temperatures. The goal is not to add more heat in this area, but to keep the material in the recommended temperature range.
- Optimize the shot-to-barrel size ratio. When using Vydyn material, two to five shots in the barrel are recommended. Having more than five shots in the barrel runs the risk of material overheating and degrading. Conversely, less than two shots in the barrel can cause poor mixing and melting, creating inconsistent fill pressures.
- Adding a second-stage fill at a lower injection velocity will allow trapped air to vent without causing burns.

- Check for adequate mold venting. Vents should be cut into the mold every 2 in. (50 mm) along the parting line from the gate to end of fill. The runners should also be vented to remove air prior to entering the cavity. The following table indicates typical vent sizes for Vydyne PA66 resins.

- Check the gate size. Gate diameter and land length are critical dimensions when designing molds for nylon materials. Gates that are too small can cause the material to experience high shear rates during fill, which can lead to burn marks. Some materials contain additives (flame retardants) that are shear sensitive and can degrade under high shear rates. Proper gate design is critical to many aspects of a quality molding cycle.

- Sharp corners on ribs, walls and other stand-offs can be areas of high shear stress. Add generous radii at the intersections of the stand-off and the nominal wall. When designing for nylon parts, a minimum radius of 1 mm (or half the nominal wall thickness) is used at corners and the bases of ribs and bosses. Parts will fill more easily and will be less prone to burning. Additionally, the part has less molded-in stress and improved functionality.

- Blind holes or ribs should be well vented to keep air from entering the melt flow front and creating burn marks.

Excessive moisture during processing is a frequent cause of burn marks. Water vapor is trapped at the end of fill and can cause burn marks to occur. Proper drying techniques, combined with well-maintained drying equipment, are crucial to ensure moisture levels in the recommended range of 0.1% to 0.20% moisture. If you suspect wet material, check the following items:

- Temperatures at the hot-air hopper inlet are typically in the range of 160°F to 180°F (71°C to 82°C).
- Maintain dewpoint temperatures in the range of –20°F to –40°F (–29°C to –40°C). If the dewpoint is too high, make sure the desiccant beds regenerate properly.
- Foreign-material contamination also causes burn marks, particularly if the material degrades at nylon processing temperatures. Maintaining a clean drying hopper, grinder and proper material handling can reduce the risk of contamination.
- Regrind particle size is very important. Regrind that is too large or irregular in shape can cause poor material feed and allow unwanted air to travel the barrel.
