Problem:

Silver Streaks

TECH TIPS

Rev. 04/2020 TT009

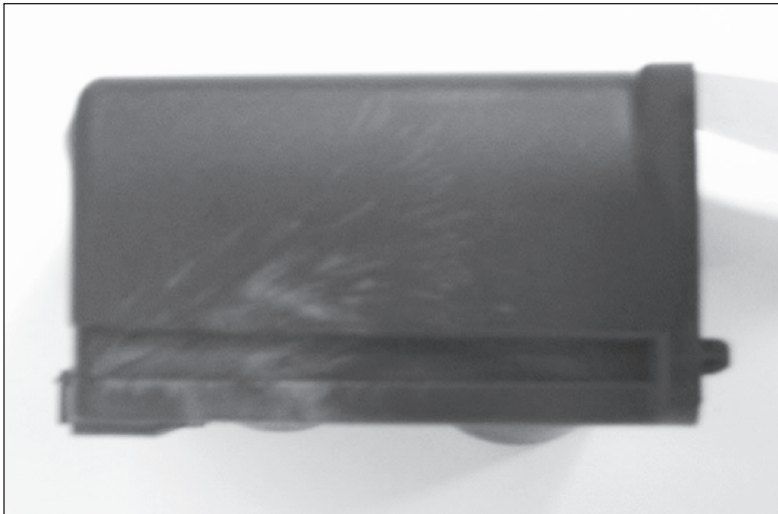
Silver streaks, otherwise known as “splay,” are surface appearance problems caused by entrapped volatiles in the melt front.

Silver streaks
